Mobile Intel[®] Pentium[®] II Processor Specification Update

Release Date: August 2002

Order Number: 243887-043

The Mobile Pentium[®] II processor may contain design defects or errors known as errata which may cause the product to deviate from published specifications. Current characterized errata are documented in this Specification Update.

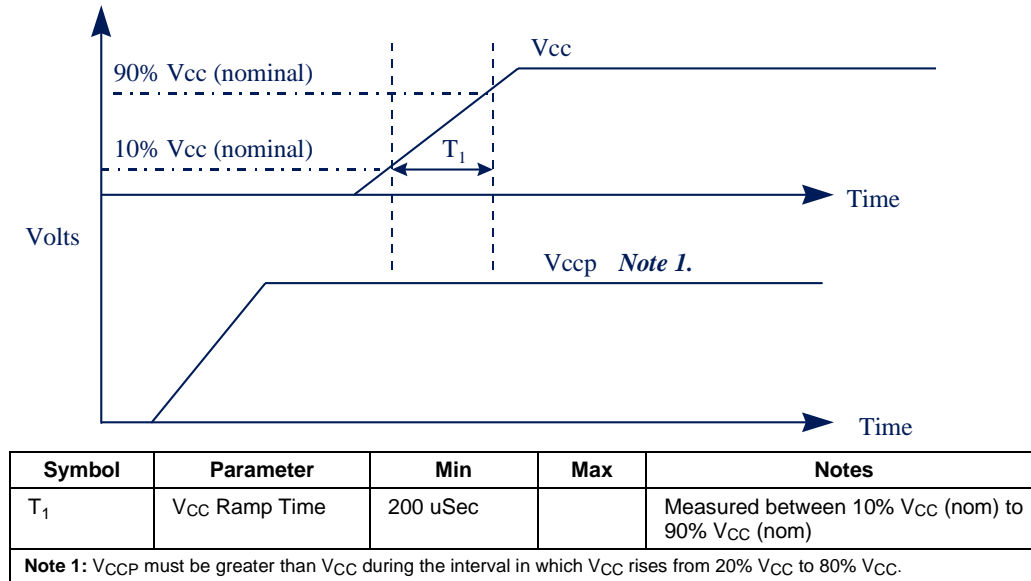
Figure 1. V_{CC}/V_{CCP} Timing Requirements (Mobile)

Problem: The processor uses the PWRGOOD signal to ensure that no voltage sequencing issues arise; no pin assertions should cause the processor to change its behavior until this signal is asserted, when all power supplies and clocks to the processor are valid and stable. However, if V_{CC} ramps up before V_{CCP} , it will cause the processor to enter an invalid state.

Implication: If this erratum occurs, the system may boot normally however, the L2 cache may not be initialized.

Workaround: For Mobile Pentium II processors, ensure that V_{CC} ramps after or with the L2 cache IO voltage (V_{CCP}). If V_{CCP} ramps after the V_{CC} , a delay circuit can be placed on the core V_{CC} to ensure that V_{CC} ramps at the same time or after V_{CCP} as shown below in Figure 1.
